# Report on Special Assistance at City of Derry Airport

November 2023

- 1.3 In 2014 the CAA issued guidance requiring airports to consult with passengers with a disability or reduced mobility. This report details the findings of a meeting on 14 November 2023 of the City of Derry Airport's Accessibility Forum which involved a tour of the airport building. The Forum is made up of a range of organisations which represent consumers with a disability or reduced mobility.

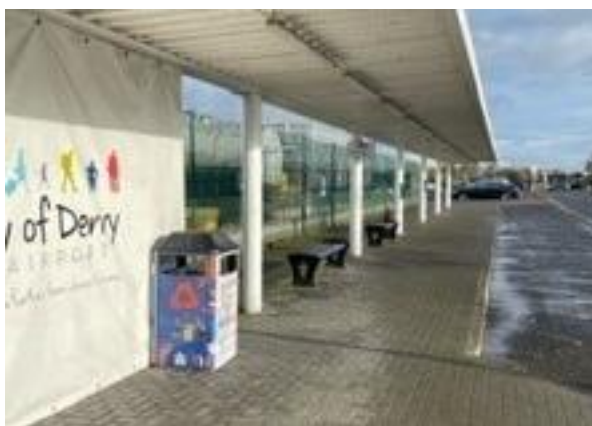
Figure 1: Bus drop off point

- 4.6 The group noted new signage at the bus drop off point which clearly highlighted the telephone number for special assistance if required. However, it would be useful to highlight the kerbs to increase visibility. The seating at this point was quite basic, with no backs or armrests (Figure 1).

- Ensure kerbs at the bus drop off point are painted in bright, contrasting colours to highlight presence to consumers with visual impairments.
- Staff to liaise with Translink to ensure that buses serving the airport are all fully accessible vehicles.
- Consider adding armrests and backs to the benches to help people with mobility impairments to sit down, balance and manoeuvre on and off the seating.

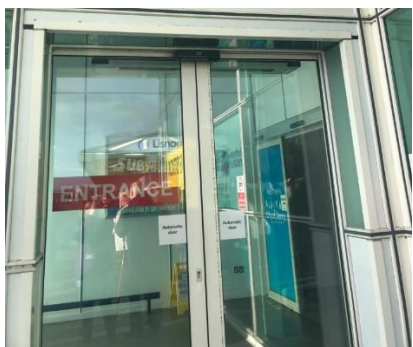
Figure 2: Side door entrance to airport

- 4.7 An “Entrance” sign had been added to the side door following a previous recommendation (Figure 2). It could be added to the blank space above the door also to assist signposting.

- Consider adding the Entrance sign on the side door to above it, to assist signposting.

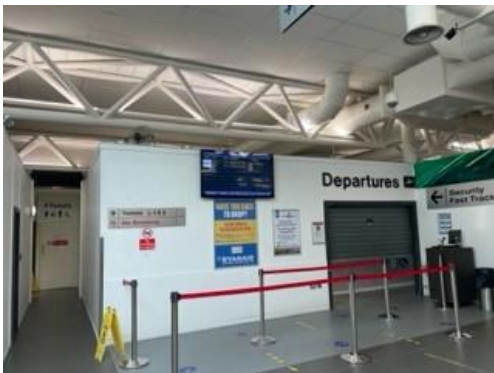
Figure 3: Flight information screen

4.9 The group also noted that the information screens were adequately sized with good text and colour contrast (Figure 3). Consideration should be given to placing one of the screens at eye level.

- Review placement of flight information screens and consider an additional screen with an increased size similar to current advertising screens. This also applies to the flight information screens in the departures area (after security).

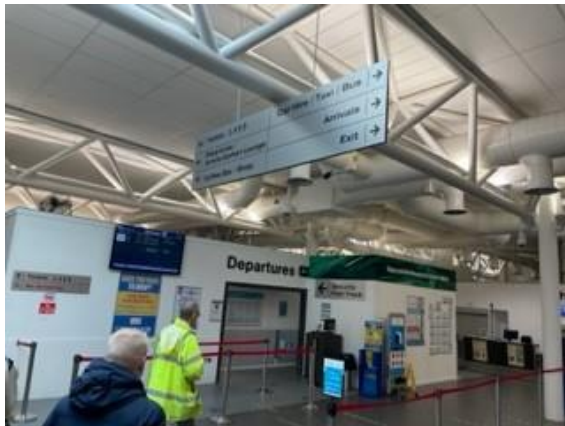
Figure 4: General directional signage at check-in area

4.10 Signage to the airport facilities was clear in strong, contrasting colours. There were some concerns that the general directional signage at the

check-in area which directed to toilets etc. was too high and therefore not immediately apparent (Figure 4).

- Consider lowering the main group of signage by the check-in area.

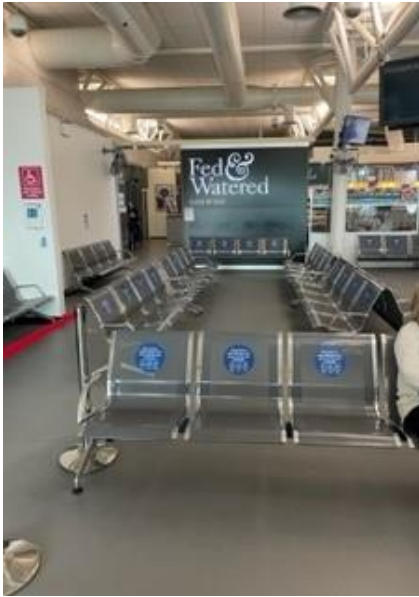
Figure 5: Seating in departures area

4.17 Participants noted that the area looked much less “busy” from the last visit with the removal of advertising signage and the dividers put in place for COVID-19 (Figure 5). The layout of the seating made it difficult for a wheelchair user to comfortably slot in beside other members of their party.

- Consider removing a small number of seats within the departures area – this will create space to accommodate wheelchair users.

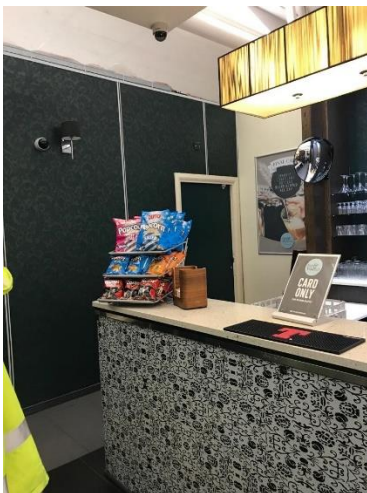
Figure 6: Main service area, Fed and Watered café

4.18 There was an accessible service area to the side of the main area in the Fed and Watered café – however this was not immediately apparent (Figure 6). Staff also informed the group that table service was available for those who preferred this. The café was “card only” and did not accept cash.

- Place a sign by the main bar area to indicate an accessible service area is available to the left hand side.
- In addition, provide a notice to state that table service is available in this area.
- Flag with Mount Charles (who operate the café) that, particularly for some older people and people with sight loss, cash is a preferable payment option.

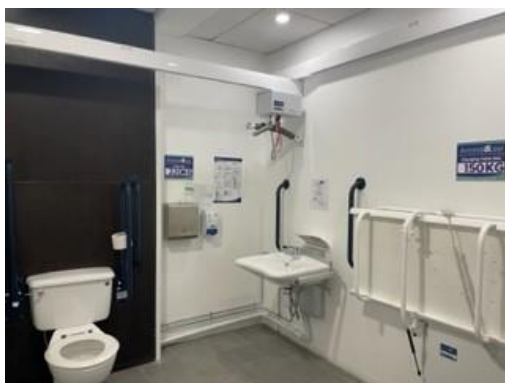
Figure 7: Changing Places toilet

4.20 Participants viewed the Changing Places toilet, installed following a recommendation made on a previous visit and which was now fully registered on the official [Changing Places website](#) (Figure 7). It was noted because of the location of the toilet it could be used by anyone and not just people flying out of the airport.
